INSPECTION REPORT

Seal Type	Burgmann MR1S5F Cartridge
Size	125mm
Material	WC/SiC/Vit/316/316-WC/SiC/Vit
Nash P/No.	BUR/MR1S5F/1250/UQVGG-UQV/OR3238/X
Cust. Ref.	Fabrik No. 07/7719
Equipment	Netzsch LMZ 150 Mill
Duty	Inks 460rpm 3.5barg Nitex Min Oil Barrier at 6 barg

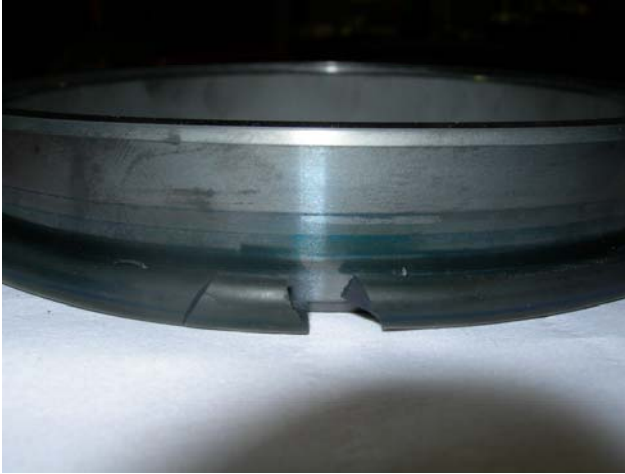
Fig.1 Inboard stationary seal ring O-ring showing section missing.

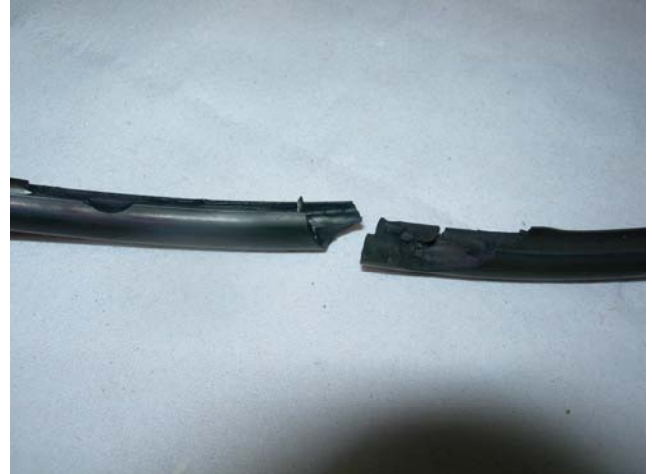
Fig.2 Inboard stationary seal ring O-ring showing nibbling and cracking

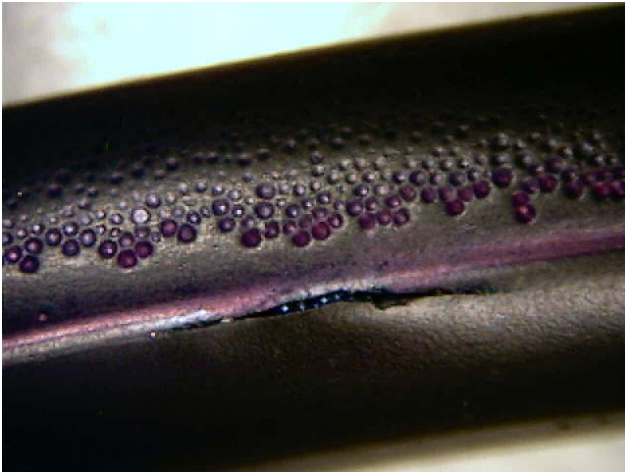
Fig.3 Inboard stationary seal ring O-ring showing indentations left by trapped beads and peeling due to softening at elevated temperature.

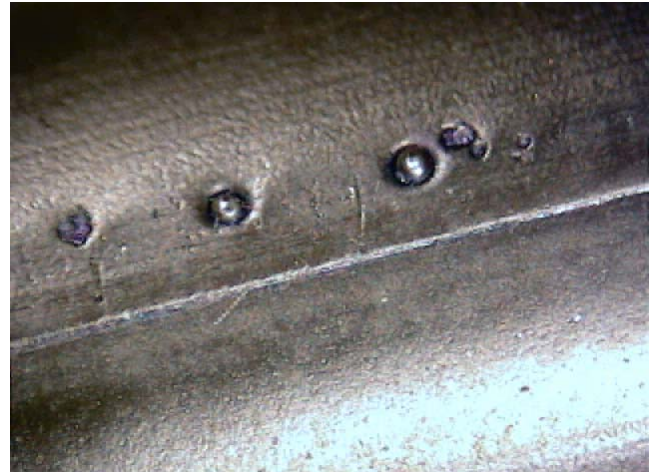
Fig.4 Inboard stationary seal ring O-ring showing beads embedded in the softened surface (ID /product side).
